Warrnambool Breakwater – January 2018

Warrnambool City Council

Port of Warrnambool Asset Management Plan

Breakwater Assessment

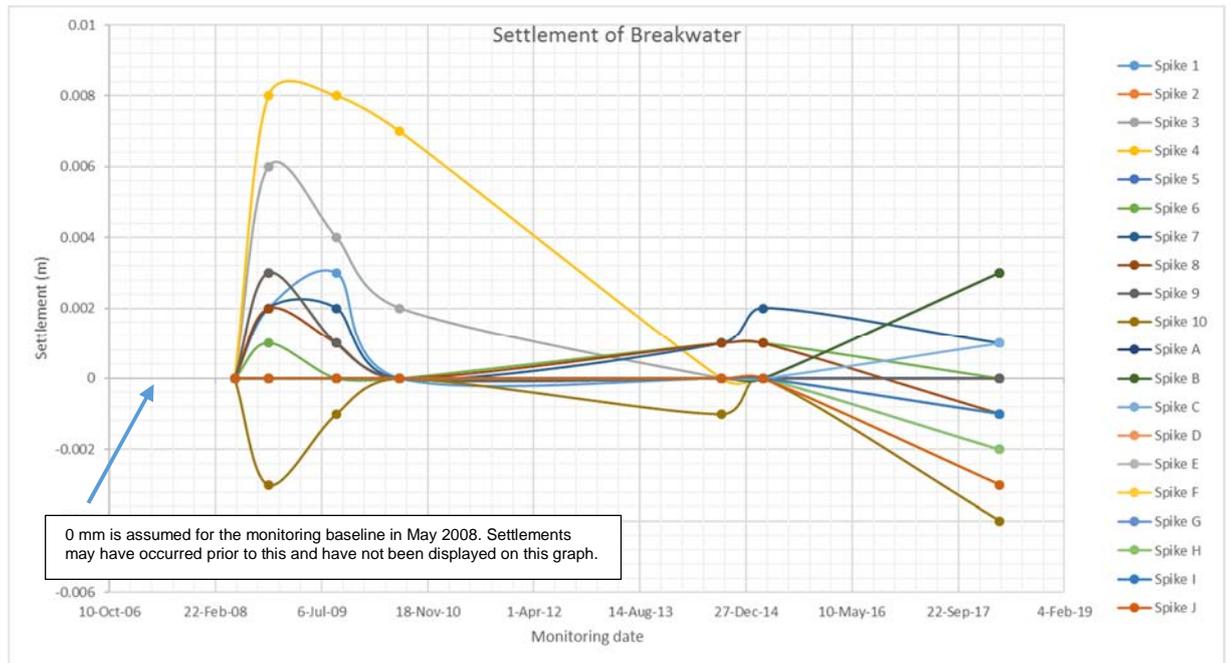
Figure 7 Warrnambool Breakwater monitoring of settlement

The survey monitoring data indicates that minimal movement in both the horizontal and vertical plane has occurred since the monitoring begin in 2008 (an approximate 10 year monitoring period). Maximum vertical settlements of approximately 4 mm was observed at Spike 10 and a heave of 8 mm observed at Spike 4. Maximum horizontal movements of approximately 12 mm were observed at Spike D with all remaining points indicating less than 10 mm movement.

Both horizontal (rotations) and vertical (settlements) of the breakwater appear to have reached a state of equilibrium and may be dormant. Based on our review of the survey data, significant further movement (both horizontally and vertically) is unlikely to occur in the near future without significant changes on the conditions experienced by the breakwater or foundations.

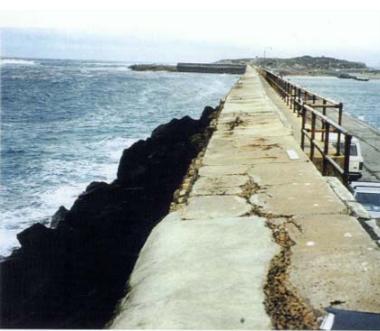
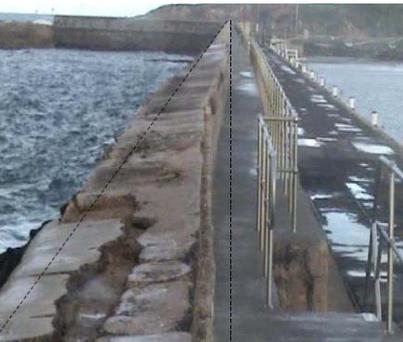
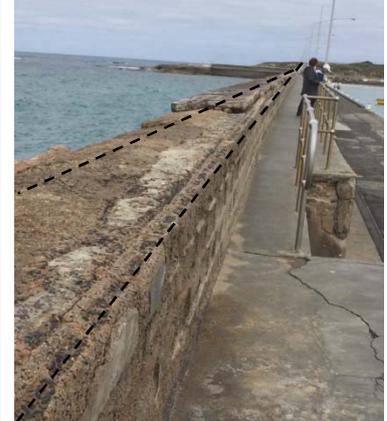
<p>Photo 22: Rotation of elevated parapet blockwork at east end of breakwater</p>	<p>Photo 23: Rotation of elevated parapet blockwork at east end of breakwater</p>	<p>Photo 24: Rotation of elevated parapet blockwork at east end of breakwater)</p>

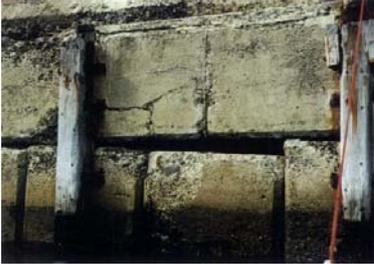
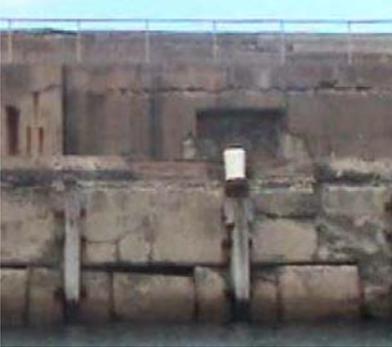
<p data-bbox="245 1373 600 1400">Photo 43: Gaps observed at Bayside</p>

<p data-bbox="639 1373 994 1400">Photo 44: Gaps observed at Bayside</p>

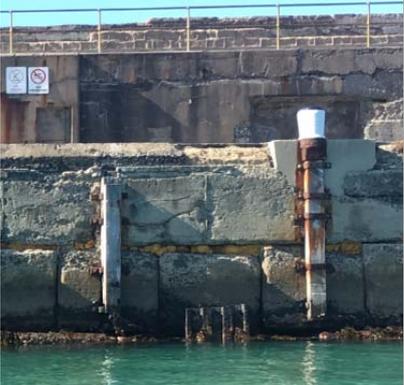
<p data-bbox="1050 1373 1388 1400">Photo 45: Gaps filled at Bayside</p>

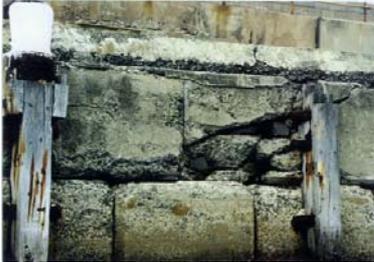
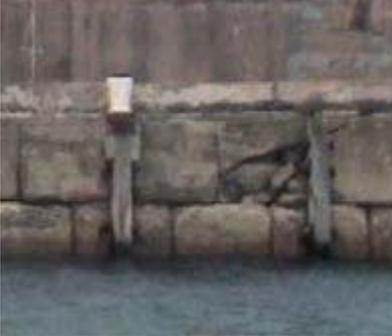
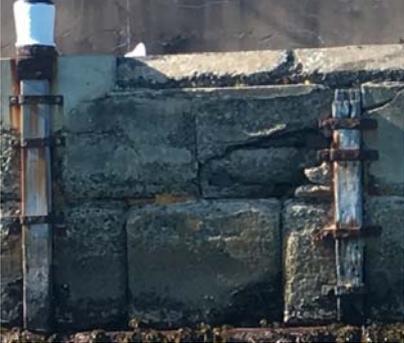
<p data-bbox="245 1771 600 1821">Photo 46: Blockwork failure due to settlement observed at Bayside</p>

<p data-bbox="639 1771 994 1821">Photo 47: Blockwork failure due to settlement observed at Bayside</p>

<p data-bbox="1050 1771 1404 1821">Photo 48: Blockwork failure due to settlement observed at Bayside</p>

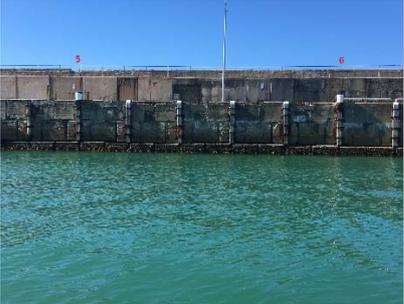
Connell Wagner report, 1998	Connell Wagner/Aurecon report, 2006/2009	GHD/Council Photos, 2017/18
		Photo 49 – Leeching of masonry block joints commencing at Bollard 5-6

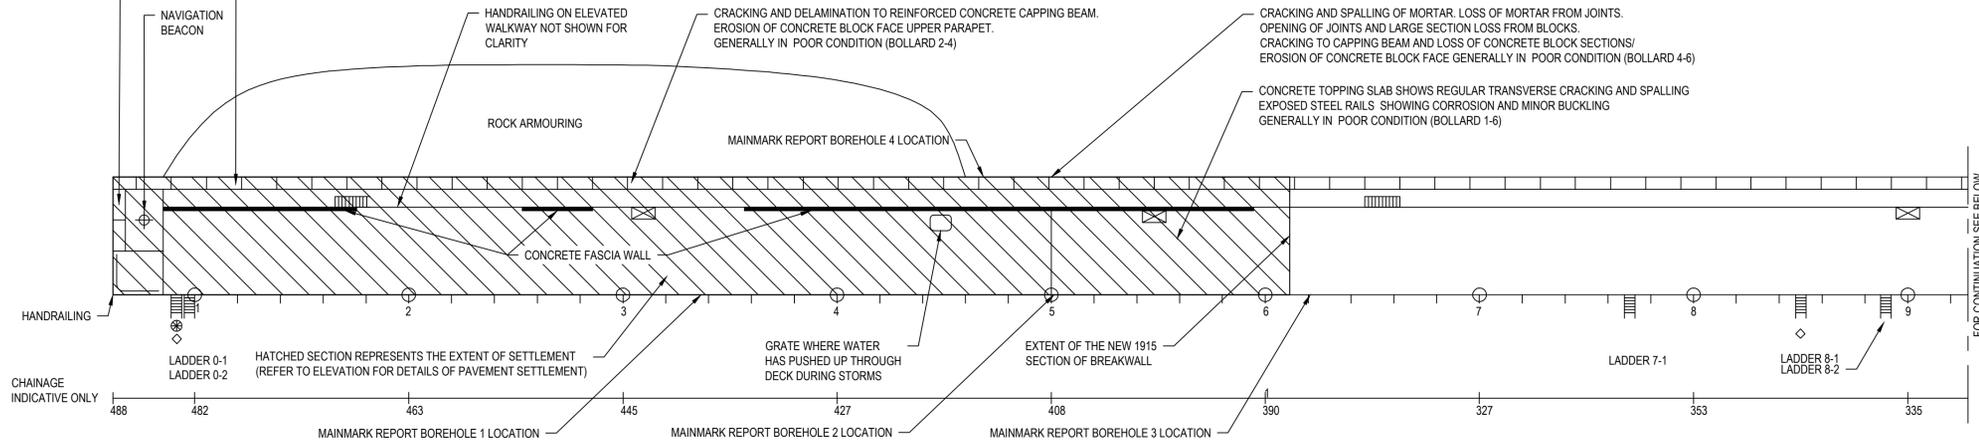
PLAN PART 1

CRACKING AND SPALLING OF MORTAR. LOSS OF MORTAR FROM JOINTS. OPENING OF JOINTS AND LARGE SECTION LOSS FROM BLOCKS. CRACKING TO CAPPING BEAM AND LOSS OF CONCRETE BLOCK SECTIONS/ EROSION OF CONCRETE BLOCK FACE GENERALLY IN POOR CONDITION (BOLLARD 4-6)

CONCRETE TOPPING SLAB SHOWS REGULAR TRANSVERSE CRACKING AND SPALLING EXPOSED STEEL RAILS SHOWING CORROSION AND MINOR BUCKLING GENERALLY IN POOR CONDITION (BOLLARD 1-6)

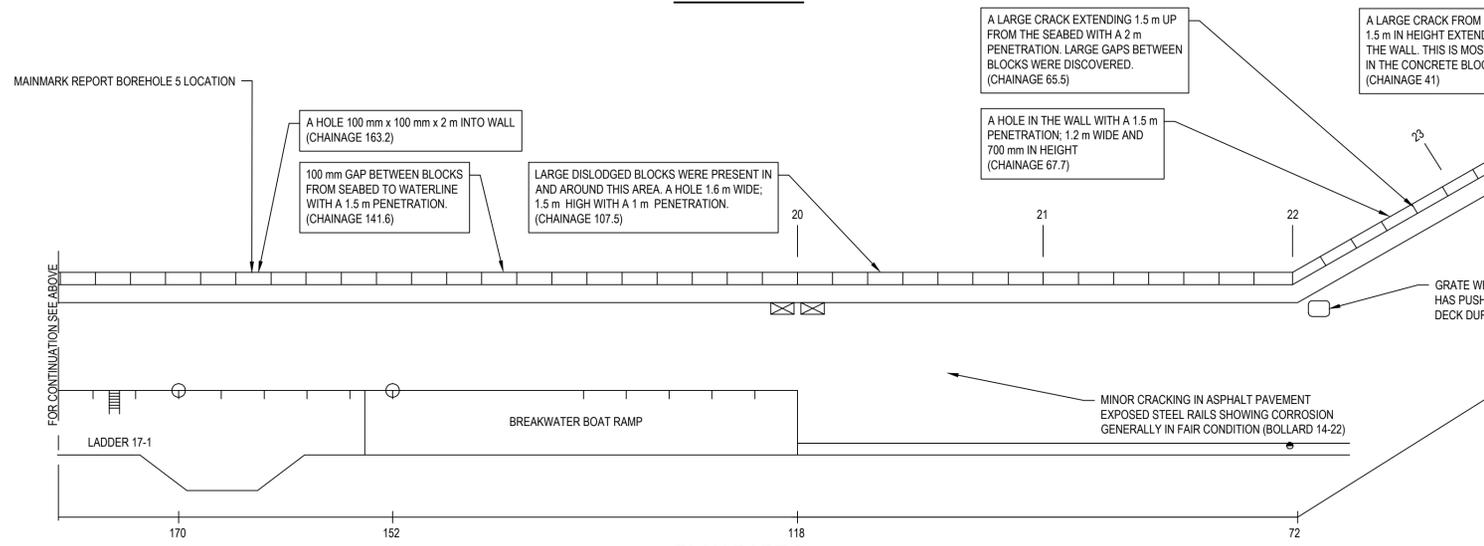
PLAN PART 3

THIS AREA EXTENDS FROM THE FIRST LIGHT POST. AN AREA OF APPROXIMATELY 6 m LONG WHERE UNDERMINING WAS PRESENT 600 mm IN HEIGHT, PENETRATING UNDER THE WALL APPROXIMATELY 500 mm. (CHAINAGE 27)
