Port of Warrnambool Asset Management Plan

Warrnambool City Council

17 August 2018

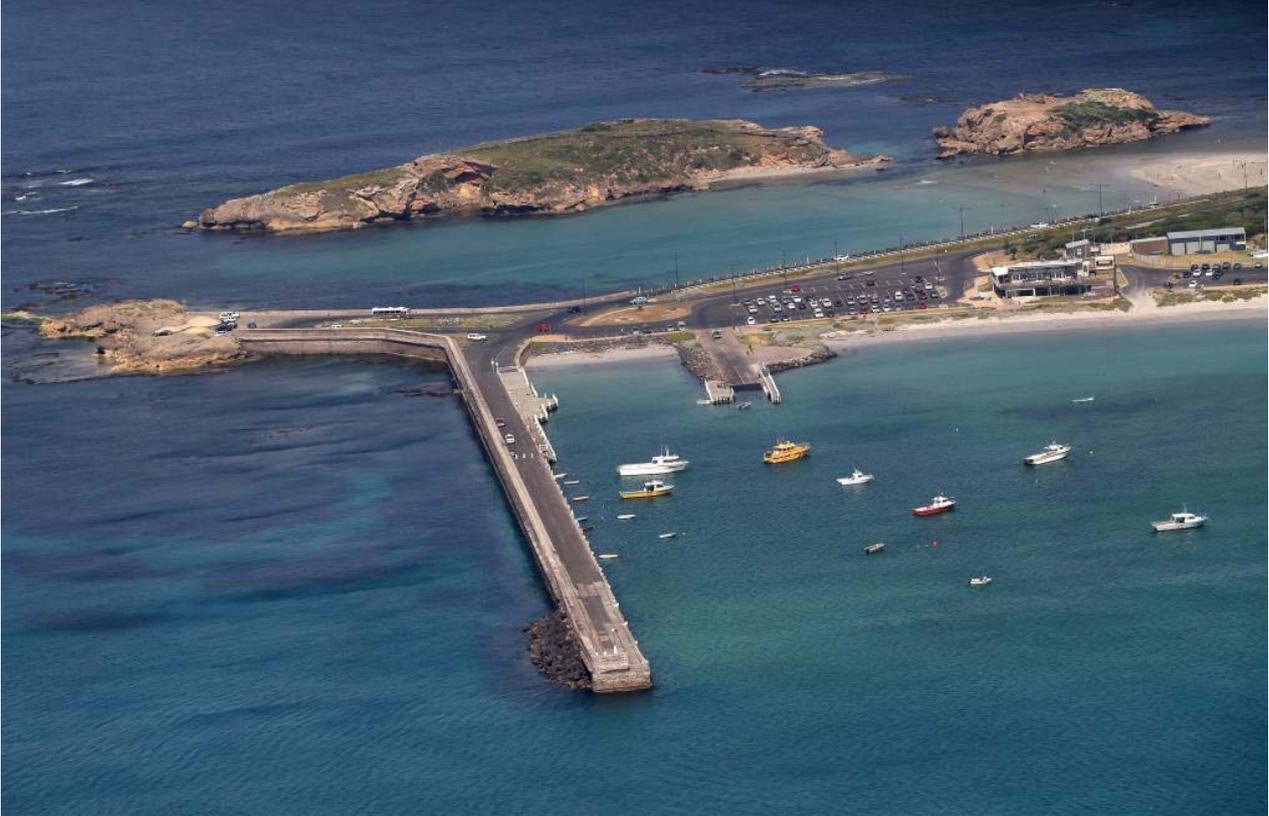
Figure 1 Aerial View of the Port of Warrnambool

The Port was designed by the eminent British harbour engineer Sir John Coode in 1879 and constructed between 1884 and 1890, and extended between 1910 and 1915. Warrnambool was the centre of a prosperous farming region from the 1840s, and following the construction of jetties in the 1850s the harbour was extensively used and was a regular stop on the coastal steamer route.

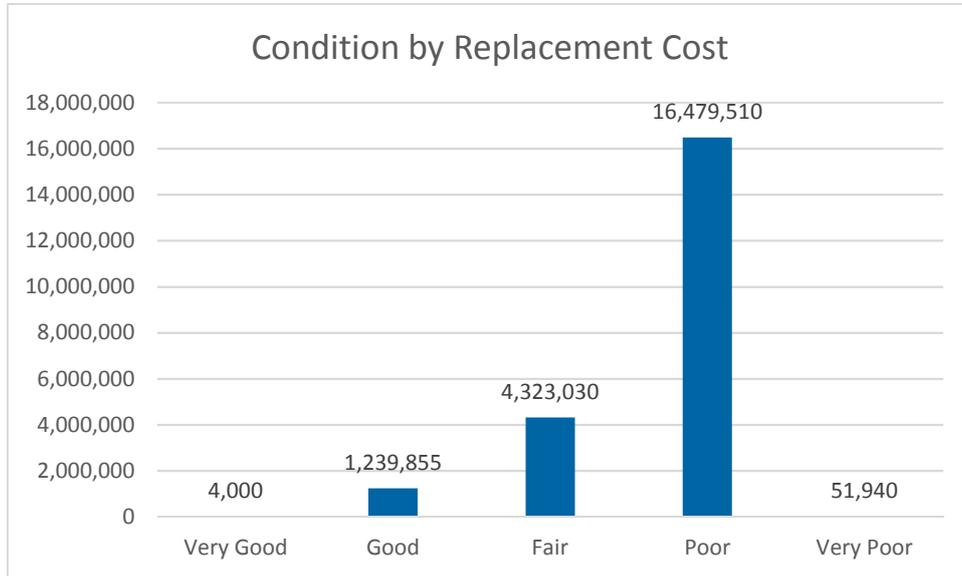
Figure 4 *Assets Condition by Replacement Cost*

Figure 4 highlights the majority of the asset replacement cost over the next 15 years is in condition 4 – Poor. The detail behind this graph is in section 4 of this AMP.

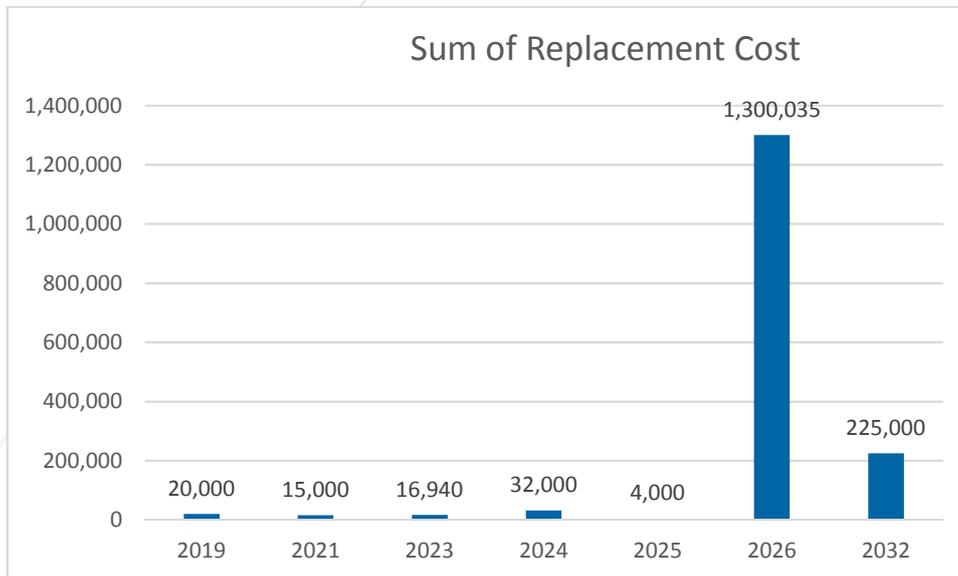
Figure 5 *Estimated Replacement Cost by Year*

Figure 5 demonstrates the yearly replacement cost over the 15 year window. Where years are not shown eg 2020 no assets were identified as requiring replacement. The detail behind this graph is in section 4 of this AMP.

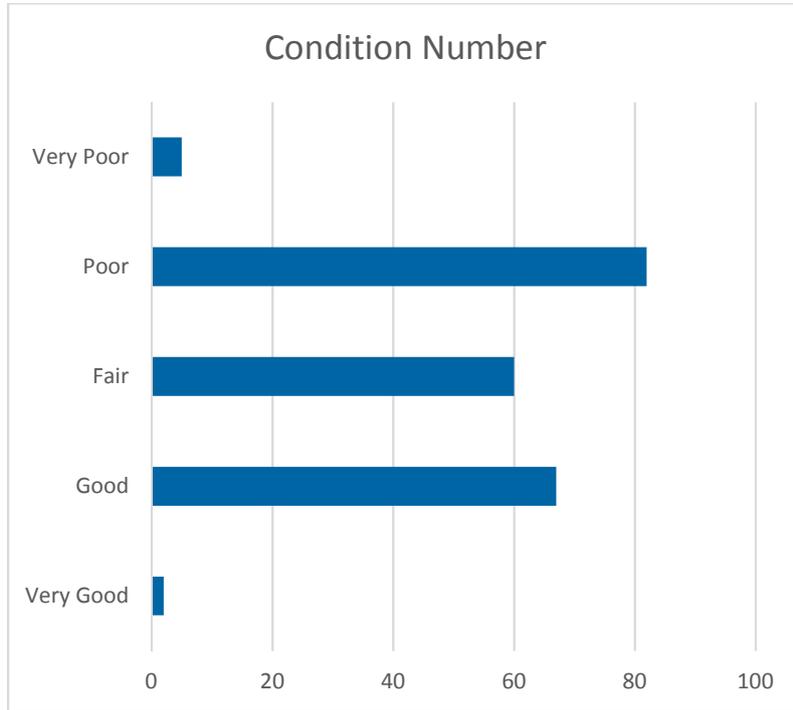
Figure 6 *Number of Assets in Each Condition*

Figure 6 highlights the number of assets in each condition grade. The detail behind this graph is in section 4 of this AMP.

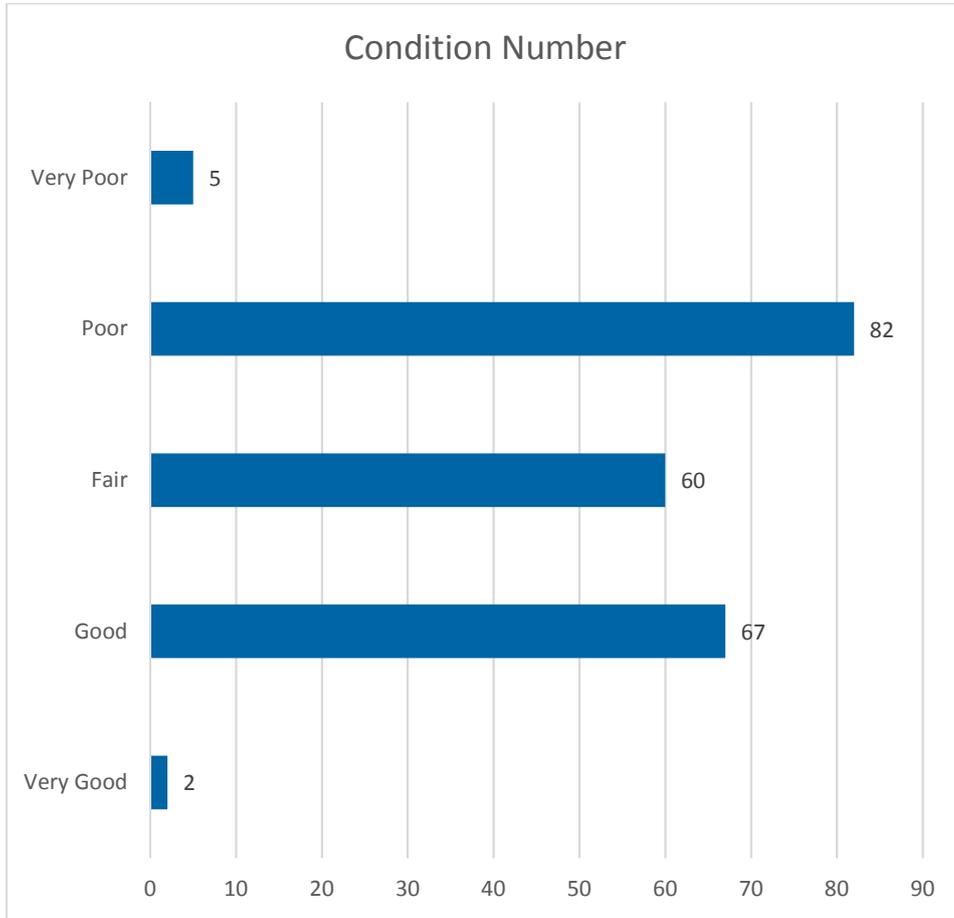
Figure 13 Assets by Condition

The graph below indicates the number of assets in each condition category. This indicates that 40% of the assets inspected are in Poor to Very Poor condition.

This table lists the asset sub types, their condition and the quantity in that condition.

Condition assessment results are provided in the spread sheets in Appendix B. The overall condition of the visually-assessed Port assets can be classified as in fair to poor condition. There are however some assets in good condition.

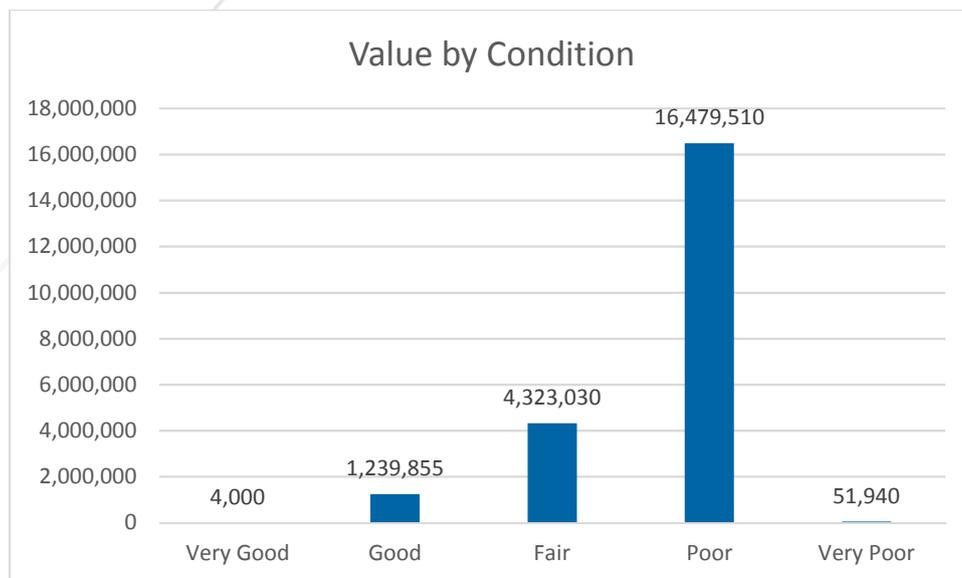
Figure 14 Value by Condition

The table below highlights the asset sub type, their condition and replacement cost

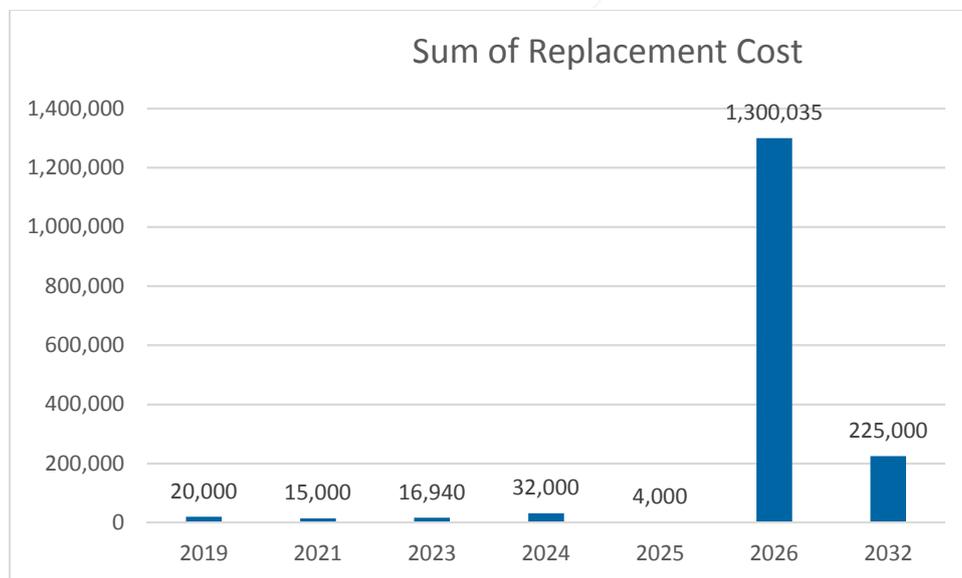
Figure 15 15 Year Spend

The following graph illustrates the estimated end of life dates for the Port assets with the associated gross replacement cost. This gives an indication of when significant expenditure will be required to renew assets. This is only showing the next 15 year window.

Year	2019	2021	2023	2024	2025	2026	2032
Sum of Estimated Renewal Cost	20,000	15,000	16,940	32,000	4,000	1,300,035	225,000

- 2026: Low Level Timber Landing On Northern Side of Breakwater (older section at eastern end)
- 2026: Timber jetty north side of boat ramp
- 2026: Timber jetty south side of boat ramp

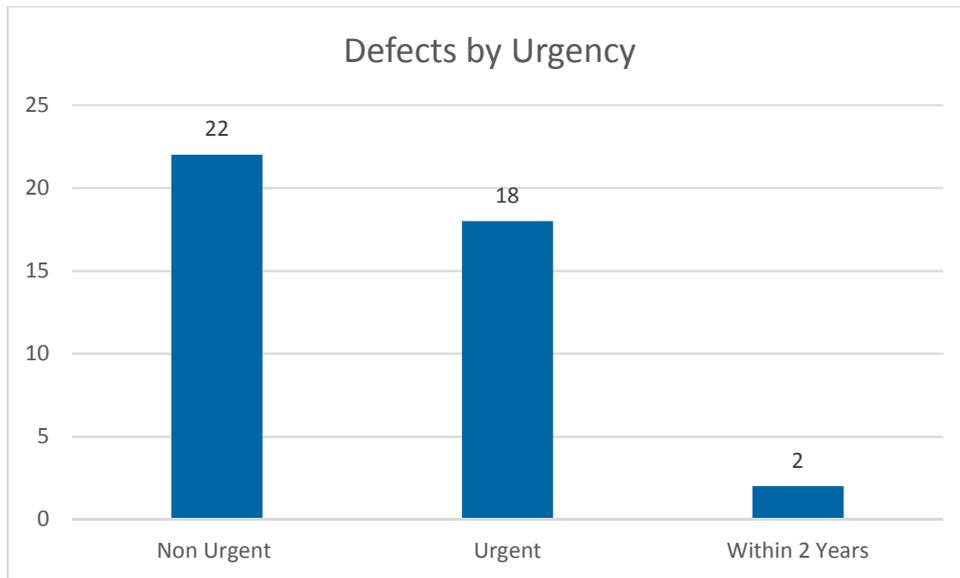
Figure 16 Number of Defects by Urgency

Urgency	Quantity
Not Urgent	22
Urgent	18
Within 2 Years	2

The defects identified were prioritised as Urgent, Within 2 years or Non Urgent. The graph above shows the number of defects in each category. The table below highlights the defects identified as Urgent.

The rock armouring is recommended on the sea side of the breakwater from sea bed, to above the high water level (to match the existing armouring). The armour would extend from the existing armour (at approximately bollard 6) to the end of the wall close to the aquarium.

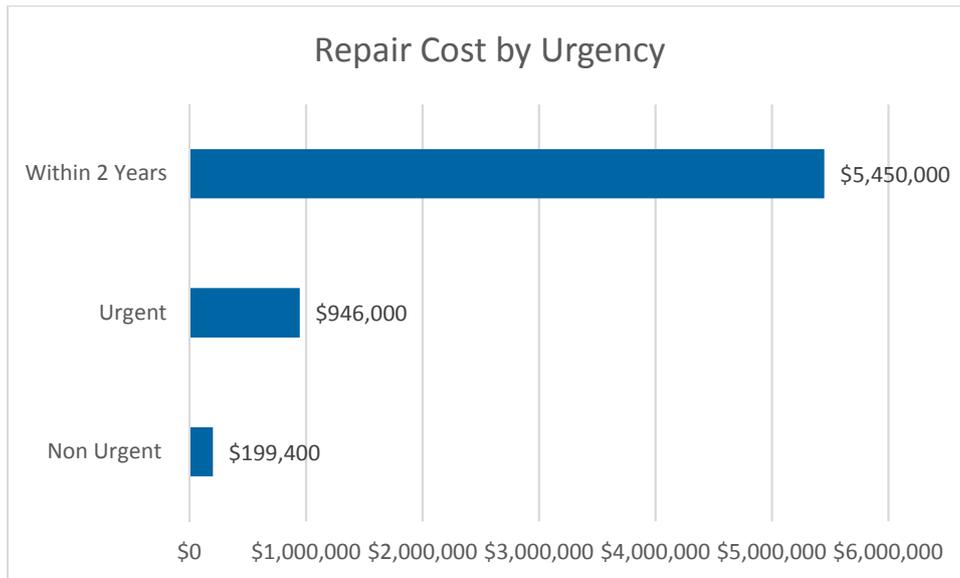
Figure 17 *Repair Costs by Urgency*

The graph below indicates the estimated cost to repair by urgency. Items in the urgent category are repairs to the parapet, fascia wall, and other surfaces on the breakwater, more detail on these repairs is given in the *Breakwater Assessment* report (GHD 2018). The major item in category of “within 2 years” is the extension of the rock armour along the seaside of the breakwater from existing armour at bollard 6 to the wall end at the aquarium.

The table below shows the assets covering each category and the estimated cost of repair.

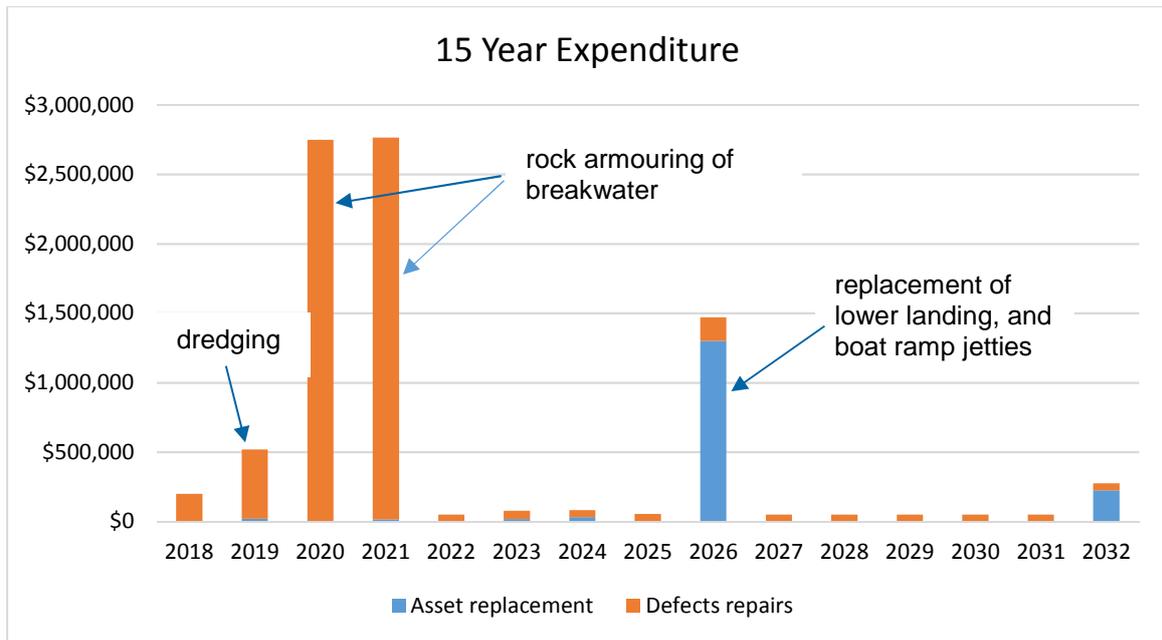
Figure 18 Expenditure

For the purposes of this graph, urgent defects have been shown in year 1 (2018, 2019), within 2 years defects in year 2 and 3 (2020, 2021) while Non Urgent have been shown over the balance of the 15 years. These years are at the discretion of WCC.

This graph demonstrates the 15 year expenditure covering asset replacement and maintenance (defect repair).
